# SkyStar Aircraft Corporation

## SERVICE BULLETIN #21A

SUBJECT: Flaperon Hinge Bearings **MANDATORY**

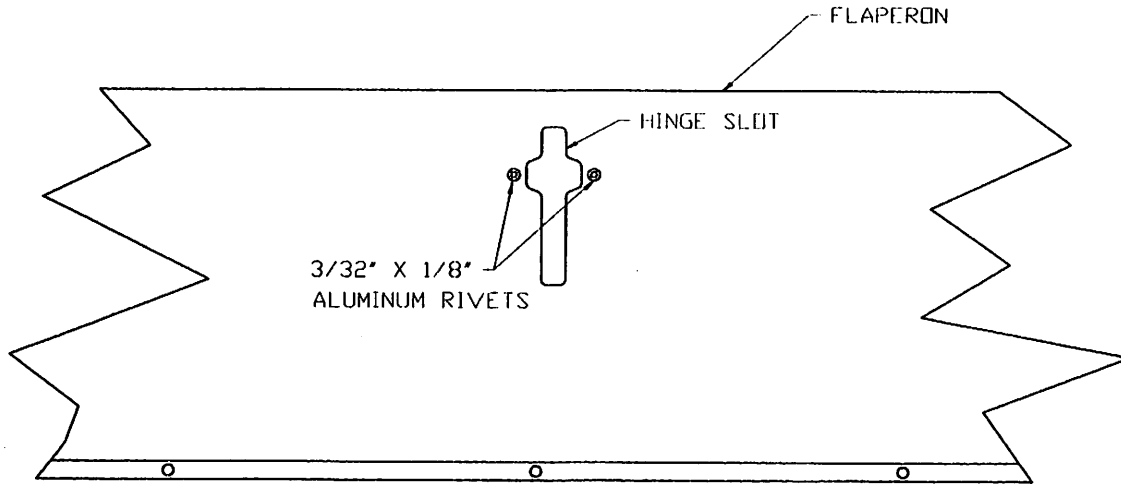
Fig. 1 (Model I, II & III)

Several Kitfox owners have reported that some hinge bearings on the flaperon torque tube have slid to one side and out of the hinge bushing. Because of the potential problems that this could create, your safety makes compliance with this Service Bulletin **MANDATORY**.

**INSTRUCTIONS:** Make sure the bearing is centered into the hinge bushing. Model I,II & III owners use Fig.-1. Drill and rivet two 3/32"x1/8" Alum. rivets through the top skin and into the flaperon torque tube 1/4" out board of each hinge opening. Model IV, Model IV-1200 & Speedster owners, determine which side of the hinge that the bearing flange is on (Fig. 2). Drill a hole approx 1/4" out board of the hinge flange in the bottom skin, large enough for a 3/32" rivet, head and all (the end of the hinge bearing extends approximately 1/2" to each side of the flaperon hing). Then drill a 3/32" hole into the flaperon torque tube approximately 3/16" outboard of the bearing. Using a short piece of 1/8" or less I.D. tubing as a spacer on the rivet pull shaft (view A-A), rivet a 3/32"x1/8" Alum. rivet into the flaperon torque tube. Creating these "stops" will hold the bearings in place, and open an extra drain hole for the hinge area.
