SERVICE BULLETIN #41

SUBJECT: Swaged Fittings on the Cross Brace Cables

APPLICABILITY: All Float Equipped Kitfoxes

FROM: SkyStar Aircraft Engineering Department

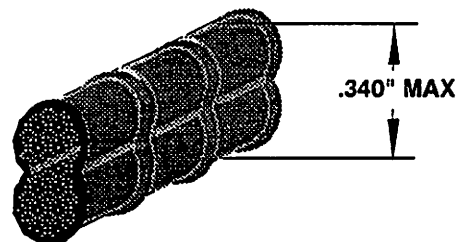
A float equipped Kitfox suffered a brace cable failure during a very hard water landing. The cable failed by pulling through the swaged nico press sleeve. Since these sleeves are rated for the full breaking strength of the cable, our investigation focused on the swaging procedure itself.

Before operating your float-equipped Kitfox again, inspect the swaging on the sleeves of the cross brace cables P/N 66021.000 for proper compression. The distance across the widest part of the oval in the swaged areas must be no greater than .340". If you find a sleeve that is improperly swaged and have access to a swaging tool, you can re-swage the sleeves to the proper depth. If you do not have a tool available, return the cables to us, and we will re-swage and return them to you. (Please call Customer Service for a RMA number before sending your cables to SkyStar for re-swaging). Upon successful inspection or re-swaging of your cable sleeves, note compliance with this bulletin in your aircraft logbooks.
