## SERVICE BULLETIN #58

SUBJECT: Nose Gear Piston Rod Bearing

APPLICABILITY: Series 5 (Vixen, Voyager), Series 6 and Series 7 Tricycle Gear

FROM: SkyStar Aircraft Engineering

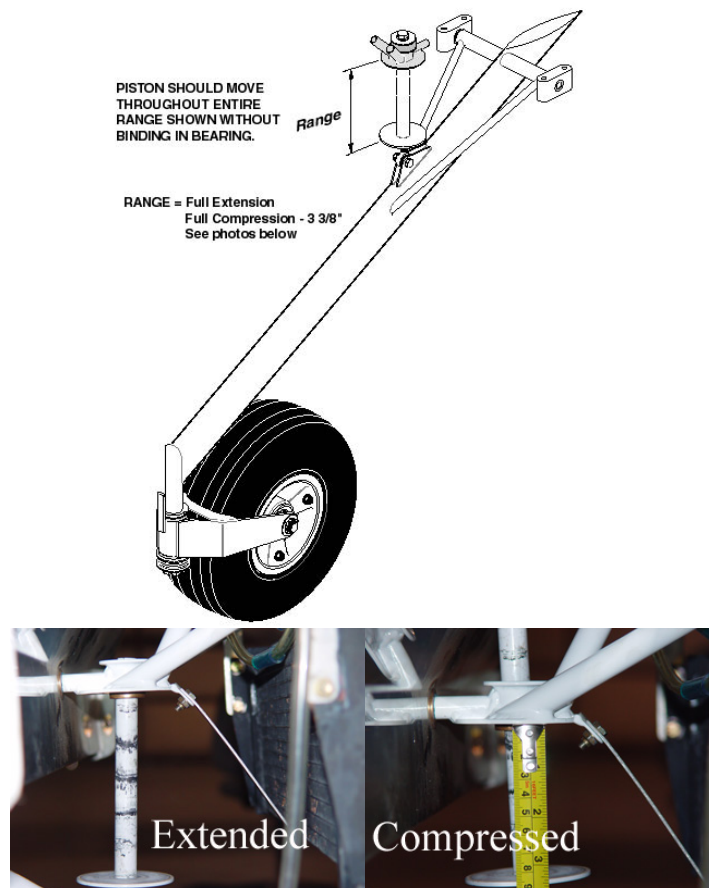
Figure 1

- Without installing the elastomers and friction washers, guide the nose gear piston back into the engine weldment.
- Attach the nose gear piston to the nose gear.
- Using figure 1 as a reference, move the piston & strut assembly through the operating range of the nose gear piston. There should be no binding when the piston is moving in this range. If there is any binding, then additional modification to the piston rod bearing is required per figure 2-1. Continue this process until no binding is present.
