SERVICE BULLETIN #9

SUBJECT: Flaperon hanger rib
TO: KITFOX MODEL I, II, III owners
FROM: Denney Aircraft Company

Attached Drawing D28002 Wing Rib Reinforcement

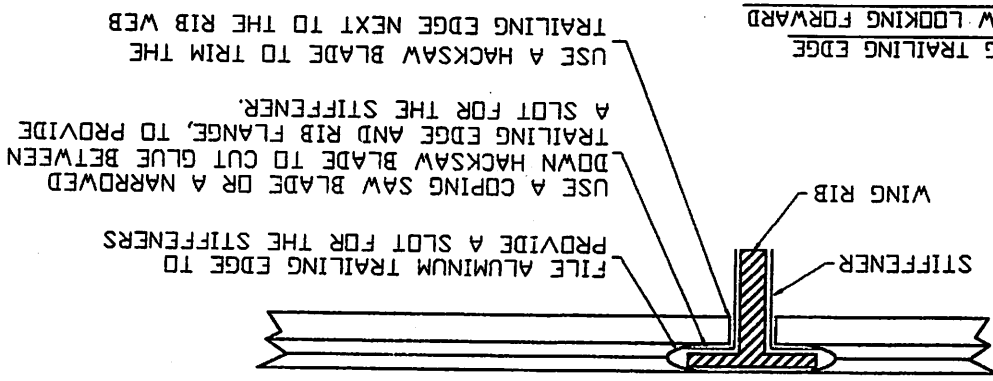
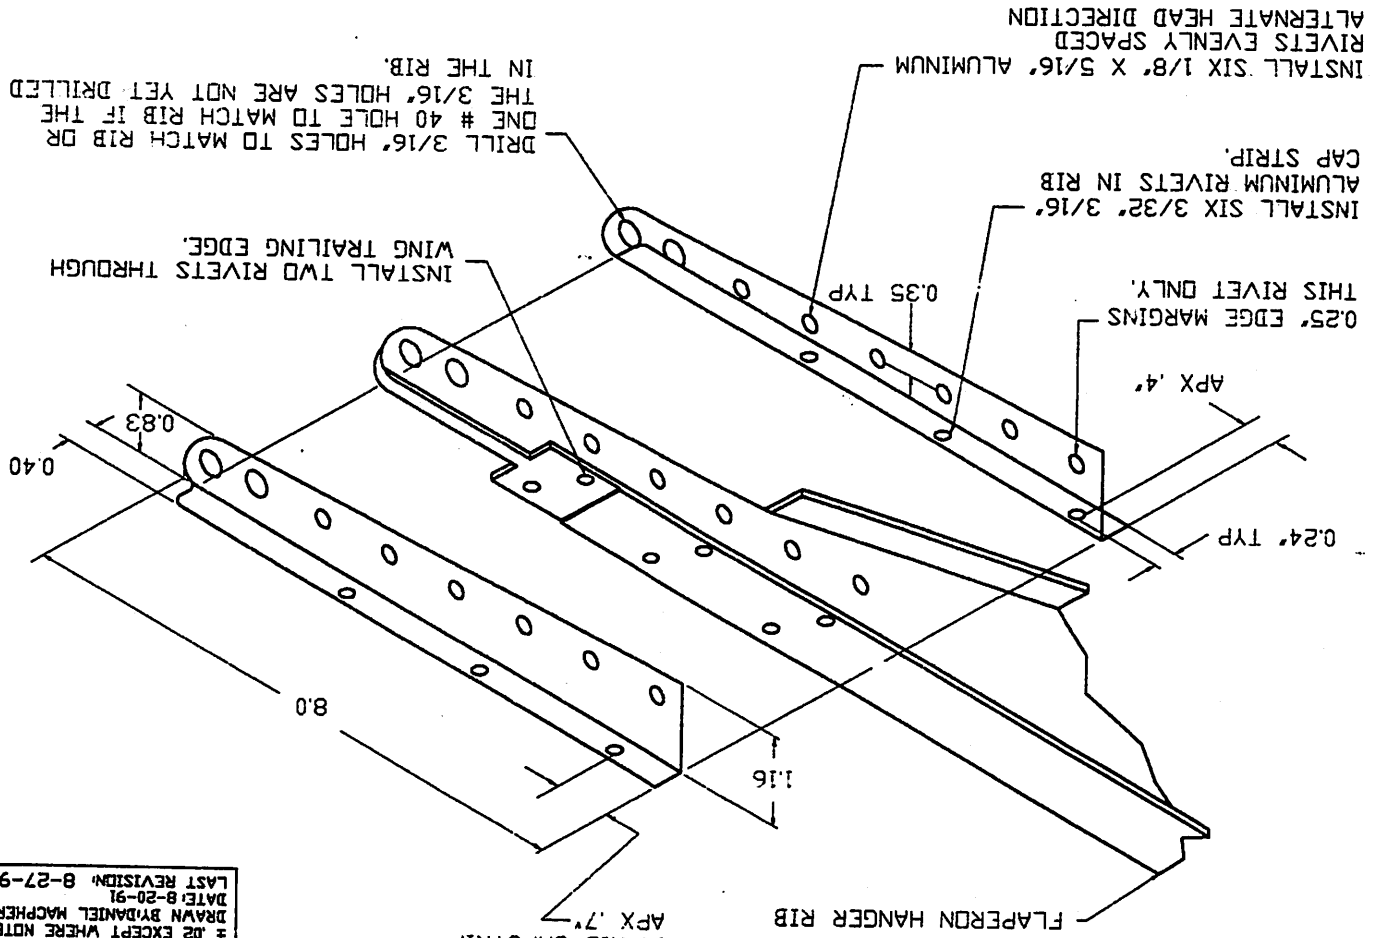
D28002
DENNEY AEROCRAFT COMPANY
100 NORTH KINGS ROAD
NAHPA IDAHO 83687
WING RIB REINFORCEMENT
ALL DIMENSIONS ARE IN INCHES
± .02 EXCEPT WHERE NOTED
DRAWN BY DANIEL MACPHERSON
DATE: 8-20-91
LAST REVISION: 8-27-91

There have been two cases of Kitfox flaperon hanger rib failure documented in the United Kingdom. In both cases the failure appeared to be from side load overstress. Both aircraft had been in recent prior ground accidents. One was in an automobile accident while being transported on a trailer. The other mishap involved a nose-over upon landing. In both cases it is very likely that there were excessive side loads placed on the flaperon hangers which could have contributed to the subsequent failures. In the latter case the failure occurred on the ground during a period of engine operation at very low RPM's including engine operation on one cylinder, which caused the entire aircraft to shake violently. There was no personal injury to any persons in either case.

The reinforcements consist of left and right .025" 2024-T3 aluminum angles riveted to each side of each flaperon hanger rib end. Each angle is 8 inches long and tapers from a depth of 1.2 inches to .8 inches with a flange of .4 inch. This flange fits flush against the bottom of the rib capstrip. The reinforcement angles are fastened to the tail of each hanger rib with 6 each 1/8 inch x 5/16 inch long blind "POP" rivets. Each aluminum angle is also riveted to the rib capstrip with 3 each 3/32 inch x 3/16 inch rivets. The builder will have to round the ends of each reinforcement angle to match the rib. He can at his option apply FSA-2 structural adhesive or the equivalent to the mating surfaces for increased joint strength. If this is done the reinforcement angle should be cleaned with acetone or MEK and rough sanded with 100 grit sandpaper.

USE A COPING SAW BLADE OR A NARROWED
DOWN HACKSAW BLADE TO CUT GLUE BETWEEN
TRAILING EDGE AND RIB FLANGE, TO PROVIDE
A SLOT FOR THE STIFFENER.
FILE ALUMINUM TRAILING EDGE TO
PROVIDE A SLOT FOR THE STIFFENERS

REINFORCEMENT MATERIAL, 0.025" 2024-T3 ALUMINUM
PART DIMENSIONS ARE TO OUTSIDE SURFACE

ALTERNATE HEAD DIRECTION
RIVETS EVENLY SPACED

DRILL 3/16" HOLES TO MATCH RIB OR
ONE # 40 HOLE TO MATCH RIB IF THE
THE 3/16" HOLES ARE NOT YET DRILLED
IN THE RIB.

INSTALL SIX 3/32" 3/16"
ALUMINUM RIVETS IN RIB
CAP STRIP.

STAGGER RIVETS .3" TO .5"
IN RIB CAPSTRIP
APX .7"
