SERVICE LETTER #38

SUBJECT: Elevator Control Stop Bushings

APPLICABILITY: All Series 5 Aircraft with S/N's prior to V9410XXXX, S9410XXXX

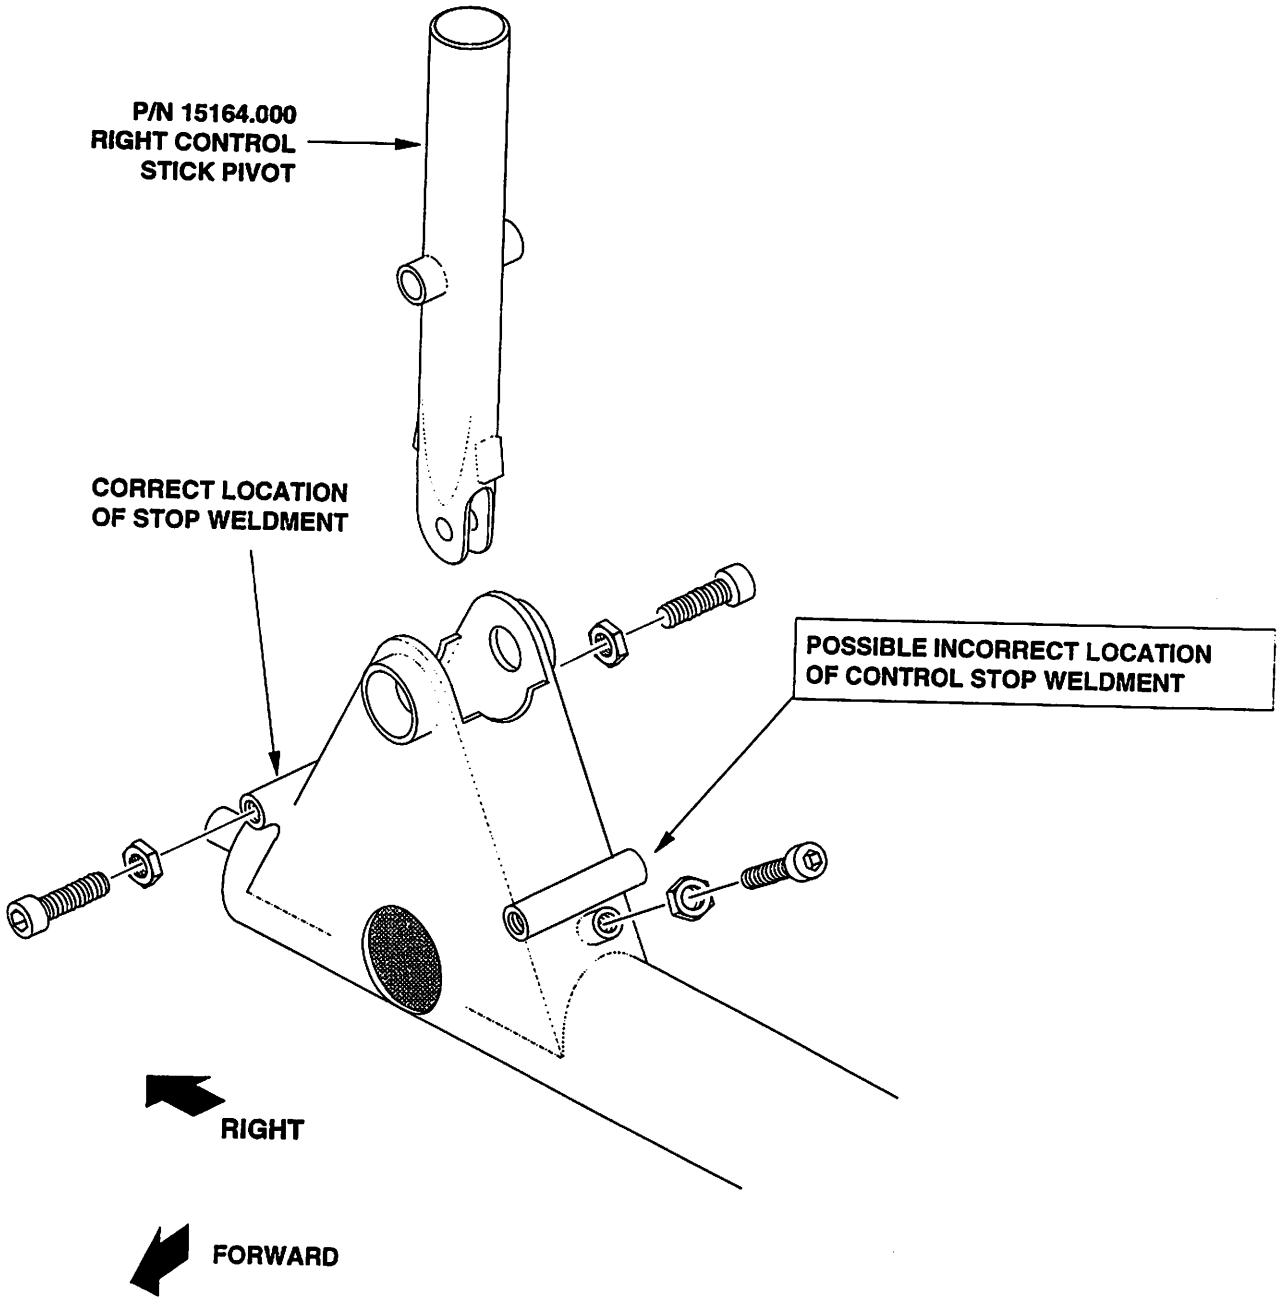
Figure 1
Control Column Elevator Stop Bushing

Some Series 5 control column weldments may have been shipped with the elevator control stop bushing welded to the wrong (inboard) side of the column. Examine your parts to determine if your control column was properly configured.

The accompanying drawing illustrates the correct and incorrect locations of the bushing in question.

If your parts are incorrect, return the parts to us and we will correct them for you. Call Customer Service for a Return Materials Authorization number (RMA) so that we may properly track the returned parts.
